A Prefabricated Flume for Gaging Ephemeral Streams

Earl F. Aldon¹ and Fletcher J. Brown, Jr.²

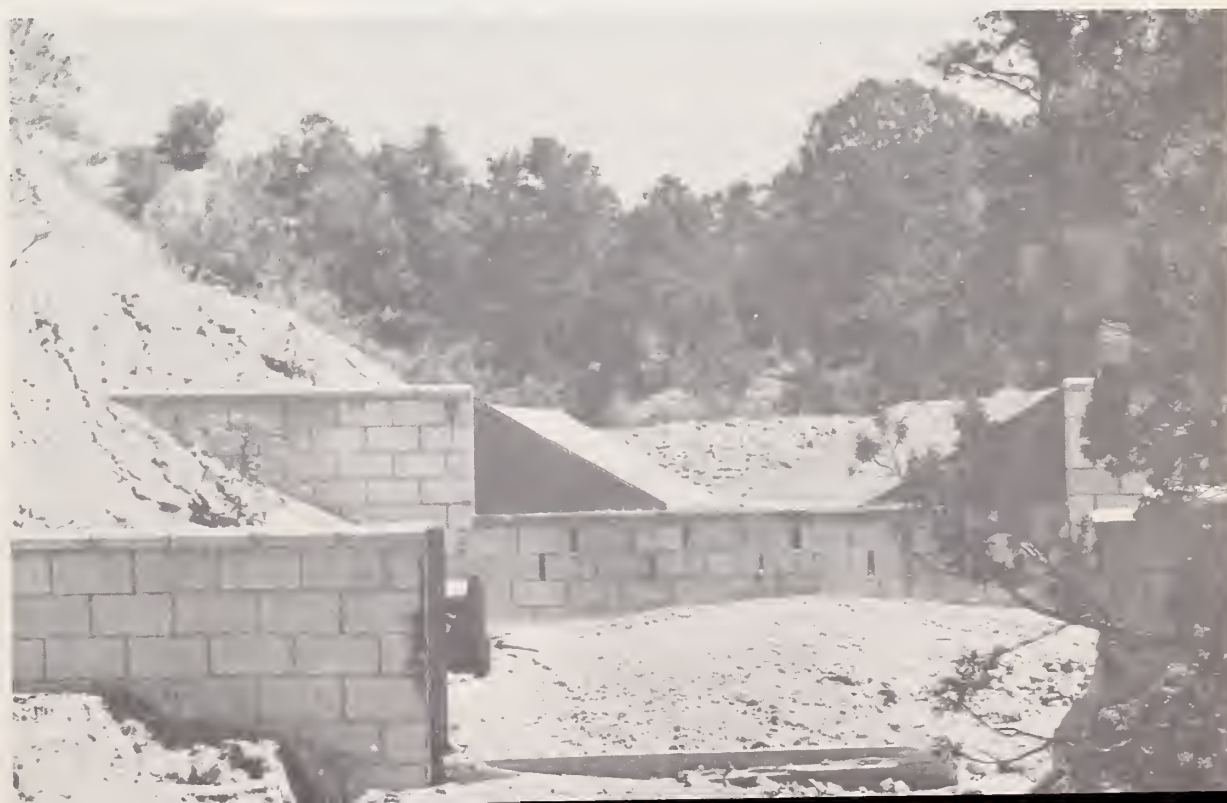
Figure 8.--A view looking upstream into the sediment basin after at least 18 tons of sediment had passed through the flume in a single flow. (The downstream sediment basin wall failed.) Flume sidewalls were scratched, but there were no dimensional changes.

vective storm released 1.57 inches of precipitation in about 20 minutes. The maximum flow was 1-1/2 feet in the flume, with a peak of 38 cubic feet per second (c.f.s.). This flow, and the resulting high sediment load it carried, sheared the downstream sediment basin wall with a resultant loss of some of the sediment in the trap (fig. 8). The 18 tons of sediment that remained, however, were cross sectioned

in the basin after the flow. Boulders, small rock, and sand comprised the bulk of this sediment. No damage to the flume, except for minor scratching of the resin finish, was found. There were no dimensional changes in the flume. The scratched areas were easily re-covered.
